# The science behind the report: The Dell Latitude 5440 survived 30 drops and still functioned properly

This document describes what we tested, how we tested, and what we found. To learn how these facts translate into real-world benefits, read the report [The Dell Latitude 5440 survived 30 drops and still functioned properly](#).

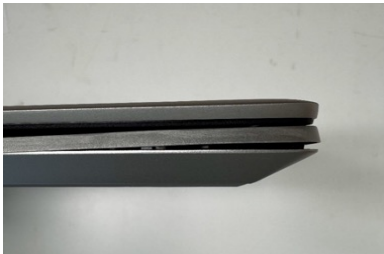
Drop 3 - Front drop	Right upper side of the display bezel came undone from the system housing. A couple scratches appeared on the top surface. System fully functional.  	Separation occurred on the left and right front bottom corners of the system. The edges of the aluminum keyboard cover were bent and scuffed. System fully functional.  
Drop 4 - Right side drop	Additional separation of the top of the display bezel. System fully functional.  	Additional separation on the right front bottom corner. System fully functional.

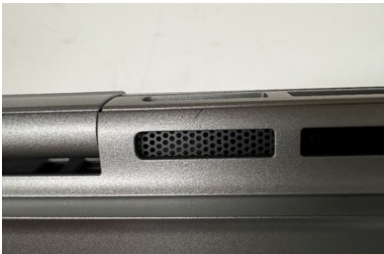
Drop 5 - Rear drop	Small scratch on the bottom surface of the system. System fully functional.

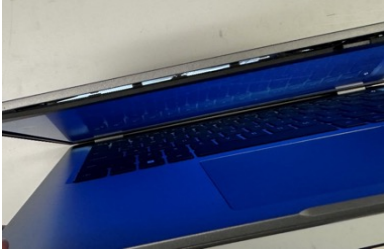
Dell™ Latitude™ 5440	HP EliteBook 640 G10
Drop 7 - Front right corner drop	<p>Additional separation of the top of the display bezel. System fully functional.</p>

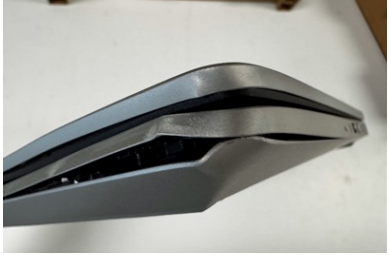
<p>Significant bending and separation occurred along the front right corner of the system chassis. System fully functional.</p>

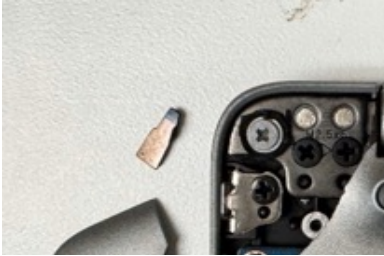
Drop 8 - Rear right corner drop	<p>A piece of the bottom cover broke off on the rear right corner. Some separation near the bottom rear right corner hinge. System fully functional.</p>

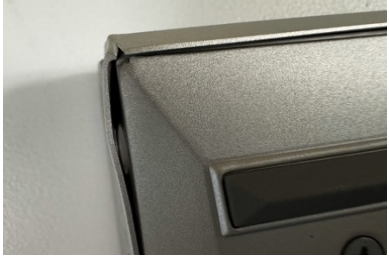
<p>Bending and small crack on the rear right corner of the chassis. Opening the device fully caused the top screen chassis to rub against the bottom of the system. System fully functional.</p>

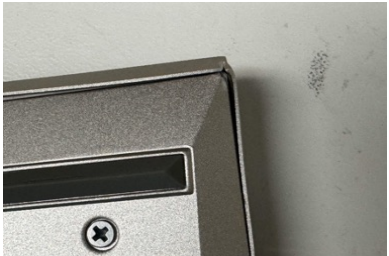
Drop 9 - Rear left corner drop	<p>No additional changes. System fully functional.</p>	<p>Slight crack on rear left corner of chassis. System fully functional.</p>

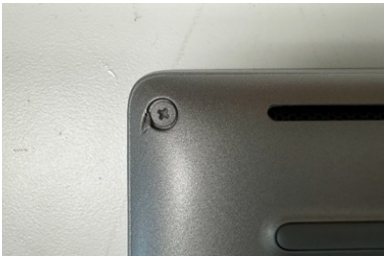
Drop 10 - Front left corner drop	<p>Small crack near the bottom front left corner screw. System fully functional.</p>

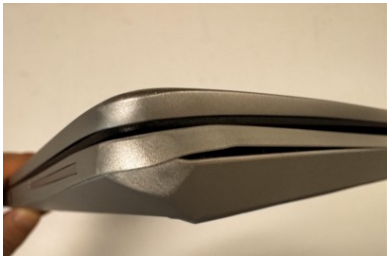
<p>The front left corner of the system chassis was bent. System fully functional.</p>

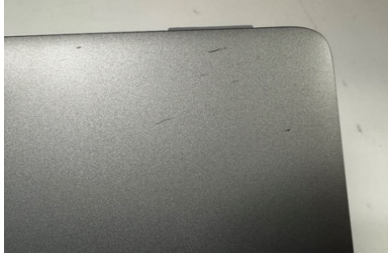
Dell™ Latitude™ 5440	HP EliteBook 640 G10
Drop 12 - Top drop	No additional changes. System fully functional.	No additional changes. System fully functional.
Drop 13 - Front drop	Some scratches on the top right corner of the top of the system. System fully functional.

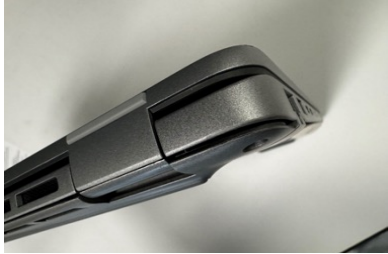
No additional changes. System fully functional.
Drop 14 - Right side drop	No additional damage. System fully functional.	No additional damage. System fully functional.
Drop 15 - Rear drop	Some separation of the bottom cover on the rear right corner. System fully functional.

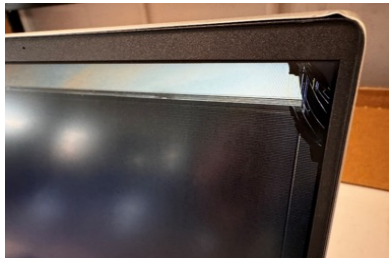
No additional damage. System fully functional.
Drop 16 - Left side drop	No additional damage. System fully functional.	No additional damage. System fully functional.
Drop 17 - Front right corner drop	No additional damage. System fully functional.	Additional bending on the front right corner of the system chassis. The screen was cracked, mostly black, and unusable. System broken and unusable.

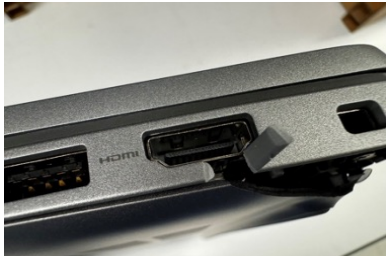
Dell™ Latitude™ 5440	HP EliteBook 640 G10
Drop 22 - Top drop	No additional damage. System fully functional.	N/A
Drop 23 - Front drop	No additional damage. System fully functional.	N/A
Drop 24 - Right side drop	No additional damage. System fully functional.	N/A
Drop 25 - Rear drop	A small plastic piece broke on the right side of the system under the HDMI port. System fully functional.

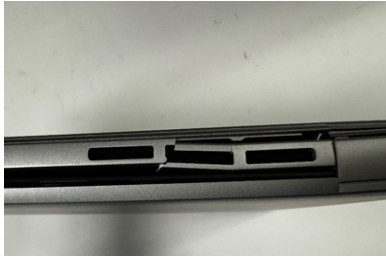
N/A
Drop 26 - Left side drop	No additional damage. System fully functional.	N/A
Drop 27 - Front right corner Drop	No additional damage. System fully functional.	N/A
Drop 28 - Rear right corner drop	The top right corner of the keyboard deck cracked. System fully functional.

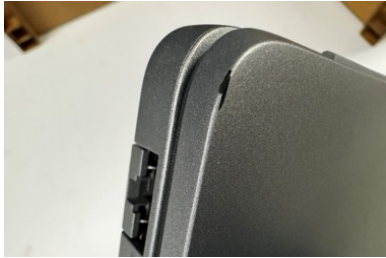
N/A
Drop 29 - Rear left corner drop	Scratch on rear left corner of system. System fully functional.

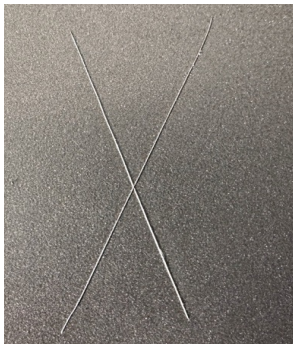
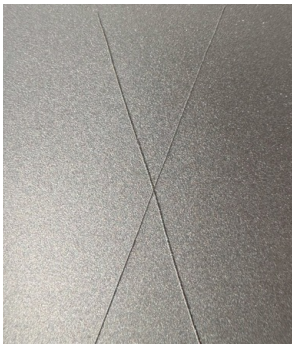
Table 2: Results of our paint quality testing.

Dell Latitude 5440	HP EliteBook 640 G10	Notes
Paint quality results			
Paint before tape removal

Coating thicknesses: Dell = ~1,800 micrometers HP = ~15 micrometers
Paint after tape removal

Before conducting the paint quality testing, we measured and noted the thickness of each system's paint coating using a coating thickness gauge.

1. Using a sharp knife blade, cut an X on the top surface of each system under test.
2. Each leg of the X should be approximately 1.5 inches in length.
3. The intersection angle of the X should be between 30 and 45 degrees.
4. Using pressure-sensitive tape, cover the entire area of the X-cut on the system under test.
5. Rub the area that has been taped with an eraser to ensure good contact between the tape and the surface of the test area.
6. Allow the tape to sit for approximately 90 seconds.
7. After 90 seconds, rapidly remove the tape at as close to an angle of 180 degrees as possible.
8. Observe the X-cut area under magnification for any peeling of the paint coating.

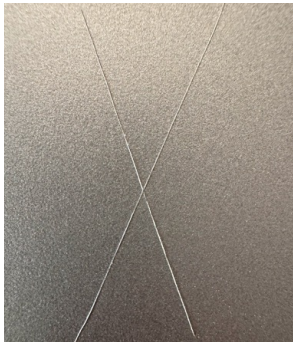
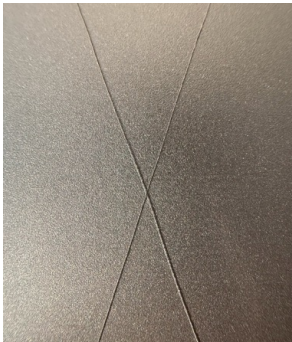
No changes after tape removal
